JCW's
Sanitary Sewer Stream Crossing
Investigation
for
KWEA 2009 Annual Conference
Presented by,
Joe Barnes and Gary Beck

Goals of Project

1. Inventory and inspect sanitary sewer stream crossings and identify crossings at risk. The at risk crossings will be selected for further investigation and ultimately design and repair.
2. Develop system for periodic sanitary sewer stream crossing investigations.

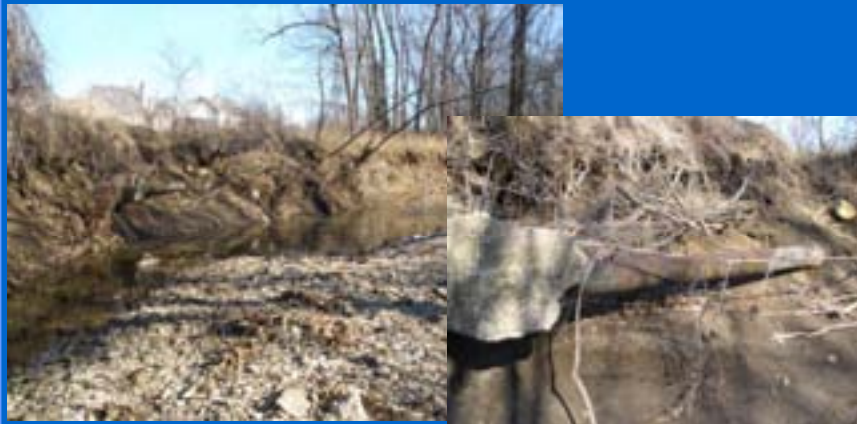
Even Parallel Sewers Are Not Safe!

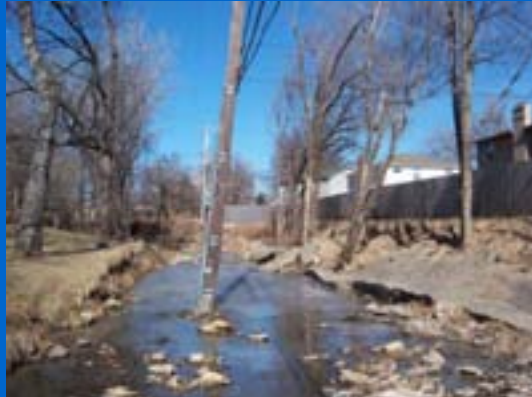
- We found that other utilities can be affected by stream channels.

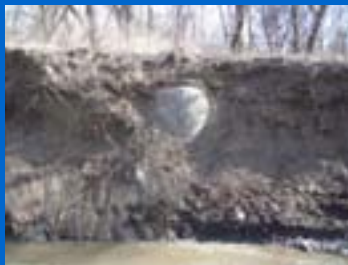
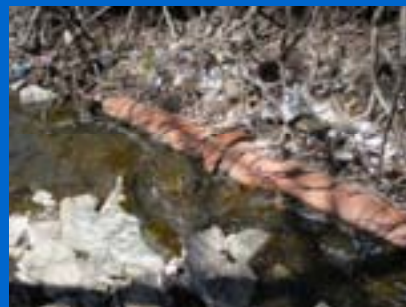
- We found that exposed sewers do not always cross a stream.

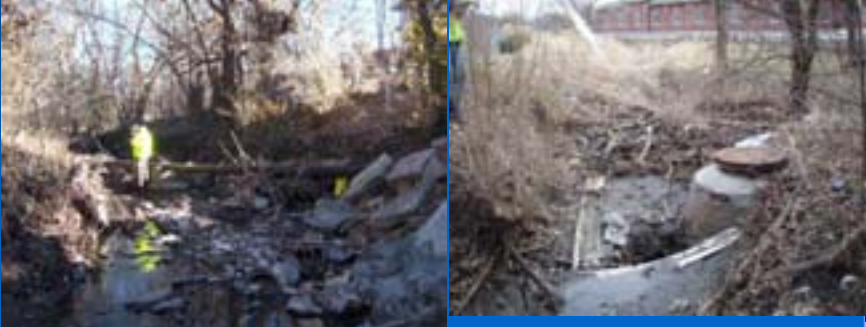
10 Sites were Reported for Immediate Attention

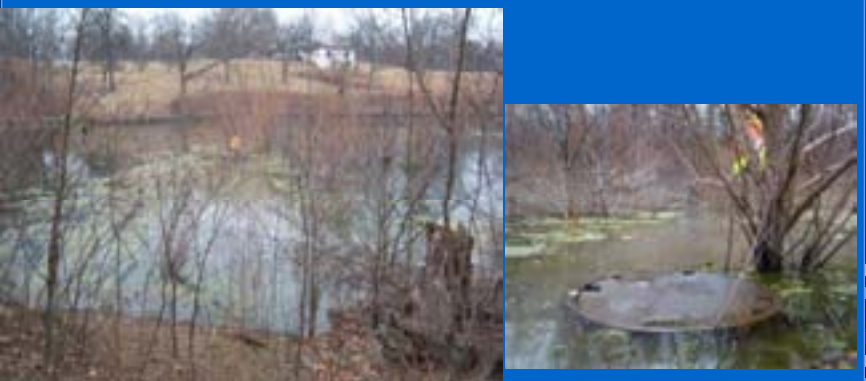
10 Sites were Reported for Immediate Attention

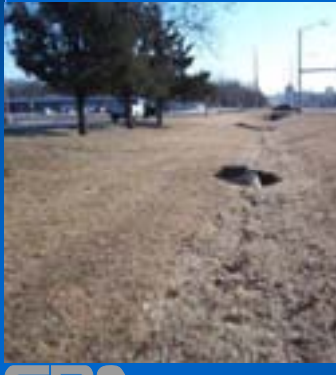
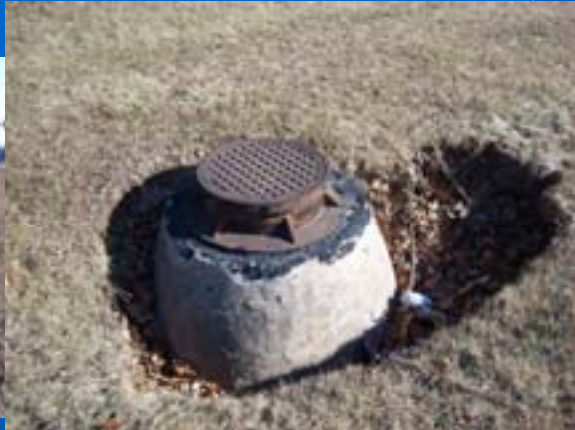
306 Manhole Were Exposed

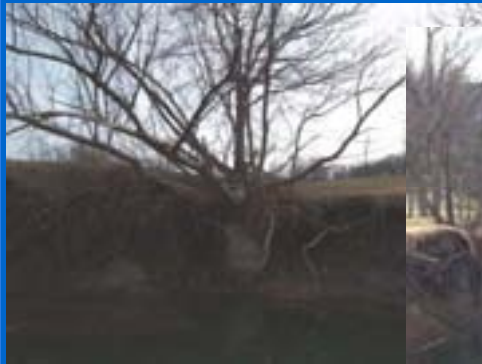
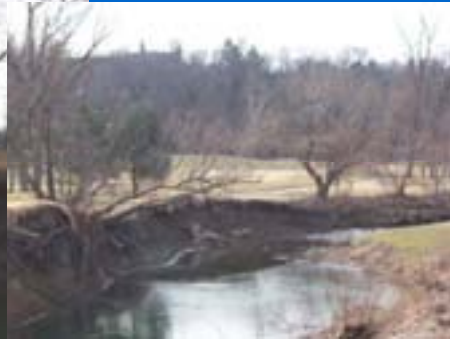
306 Manholes were Exposed

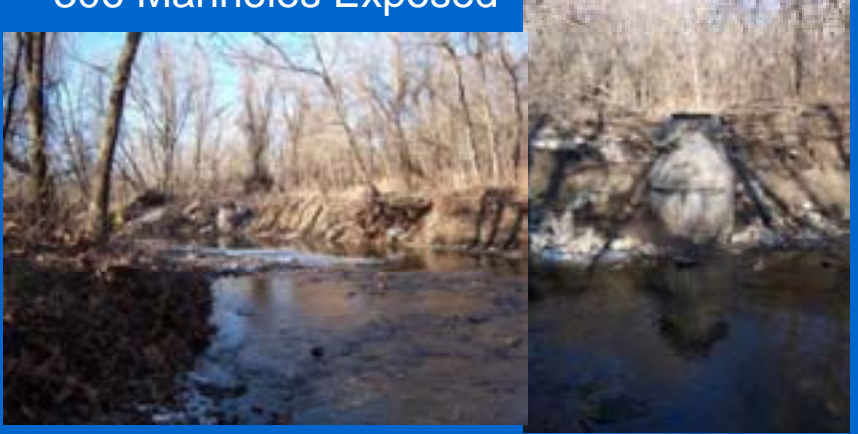
306 Manholes Exposed

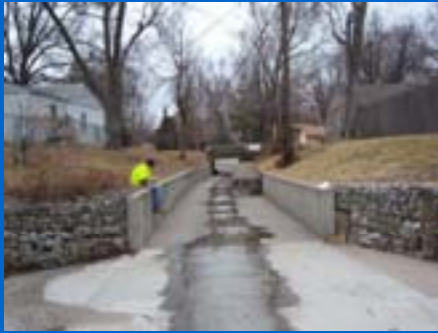
306 Manholes were Exposed

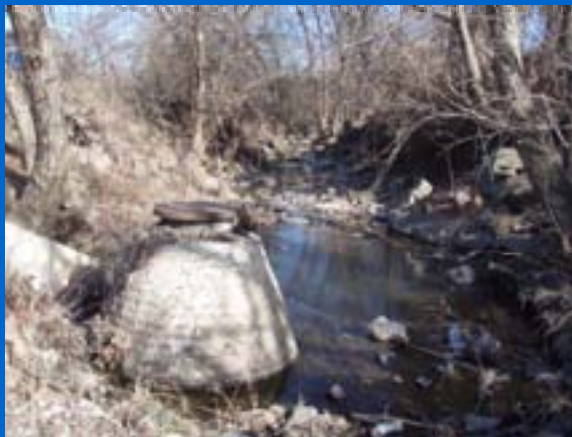
306 Manholes were Exposed

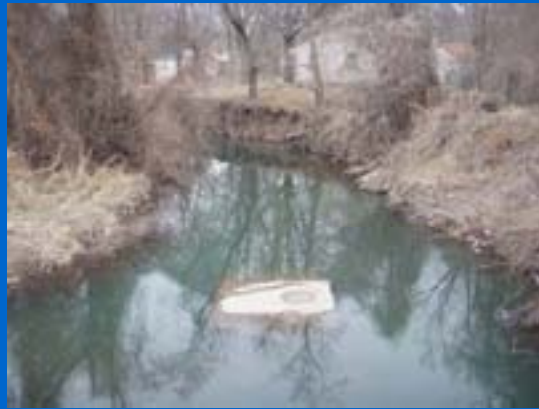
306 Manholes were Exposed

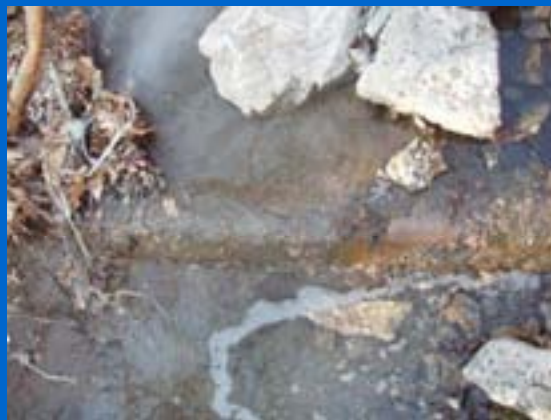
28 Pipe Exposures

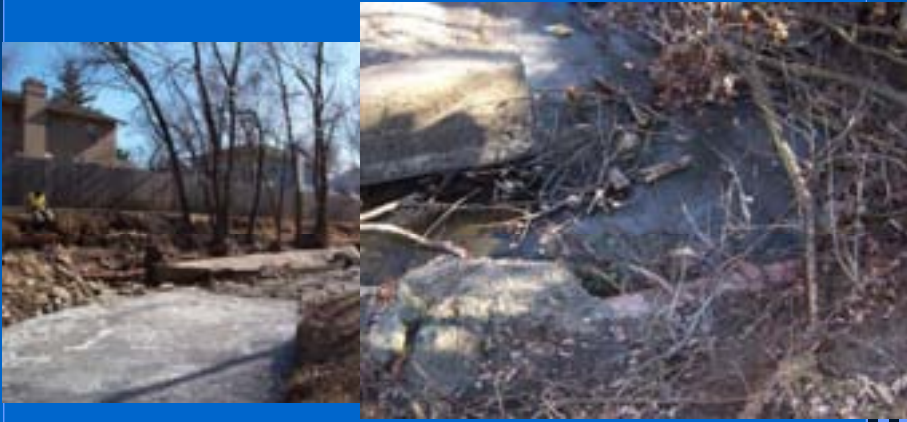
28 Pipe Exposures

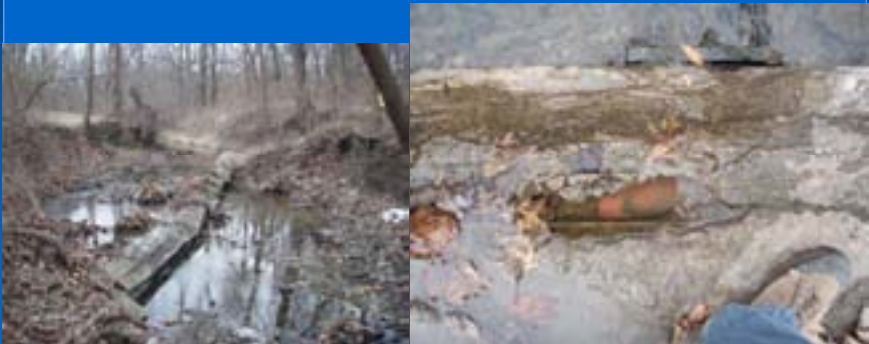
28 Pipe Exposures

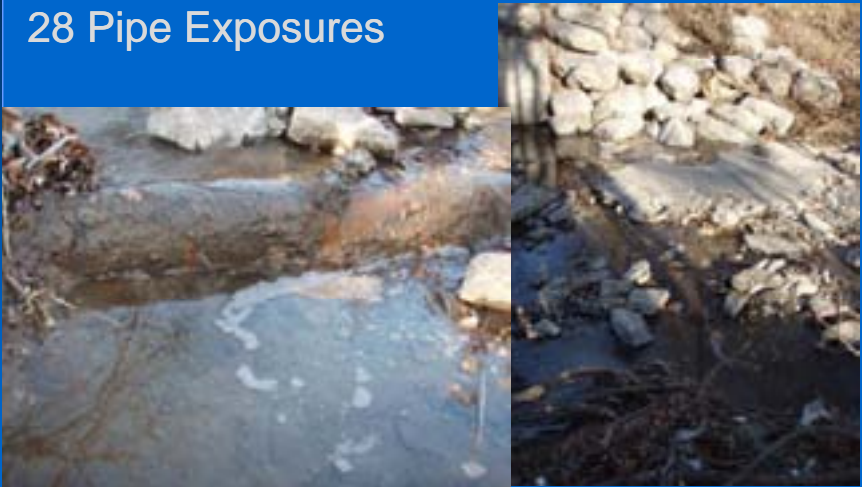
28 Pipe Exposures

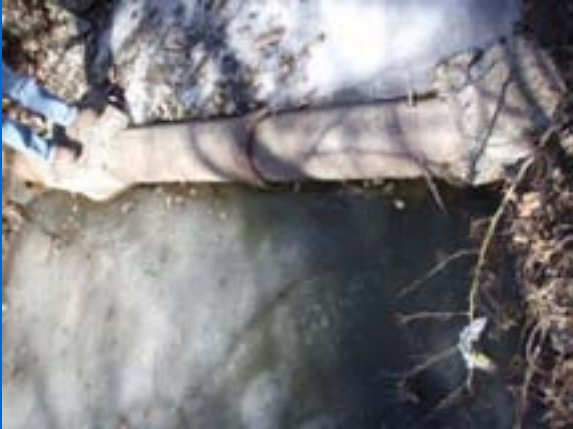
28 Pipe Exposures

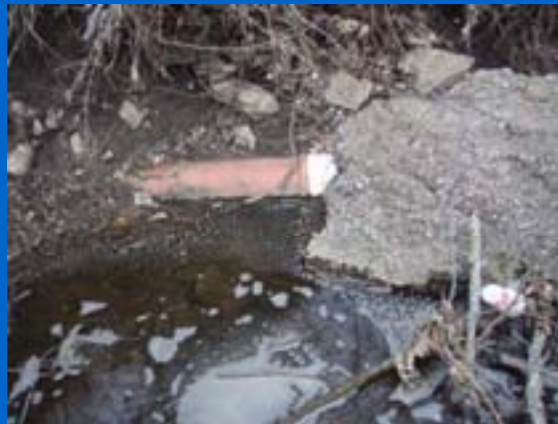
28 Pipe Exposures

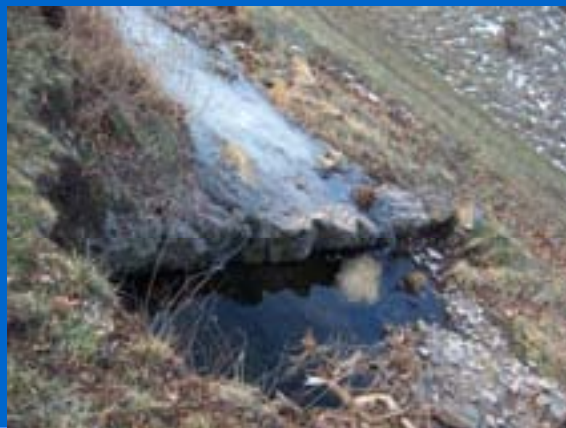
Many Exposures had Scouring Problems

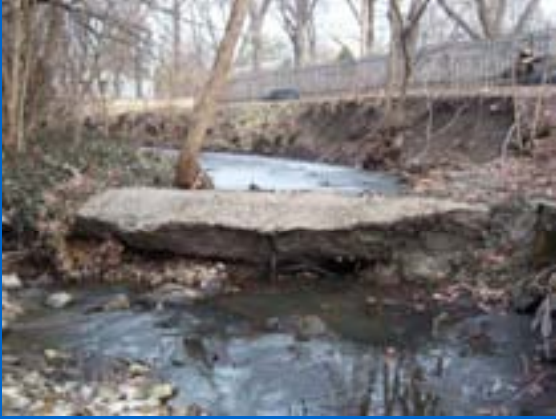
Investigation Results
Many Exposures had Scouring Problems

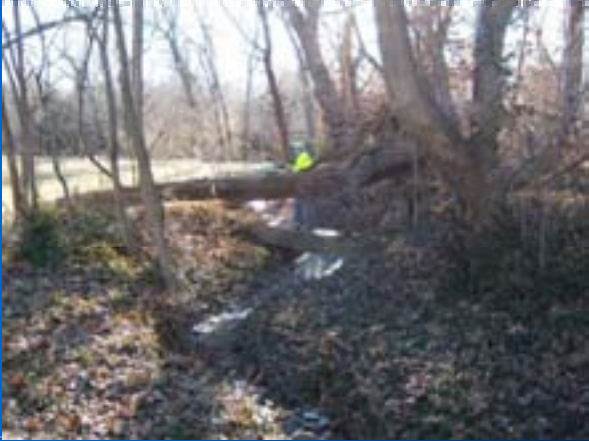
Investigation Results
Many Exposures had Scouring Problems

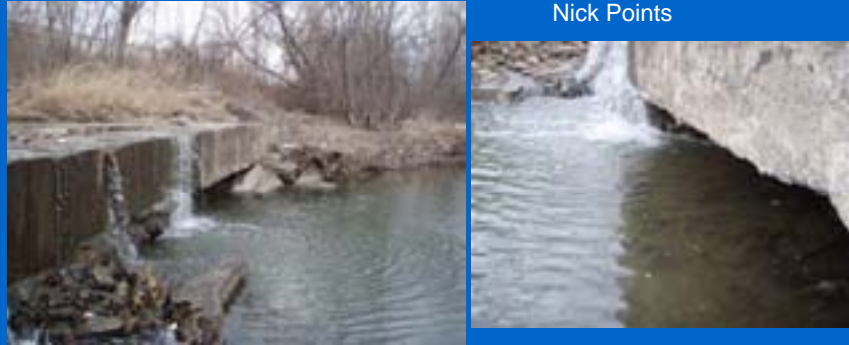
Many Exposures had Scouring Problems

Nick Points
