JCW's
Sanitary Sewer Stream Crossing
Investigation
for
KWEA 2009 Annual Conference
Presented by,
Joe Barnes and Gary Beck

Goals of Project

1. Inventory and inspect sanitary sewer stream crossings and identify crossings at risk. The at risk crossings will be selected for further investigation and ultimately design and repair.
2. Develop system for periodic sanitary sewer stream crossing investigations.

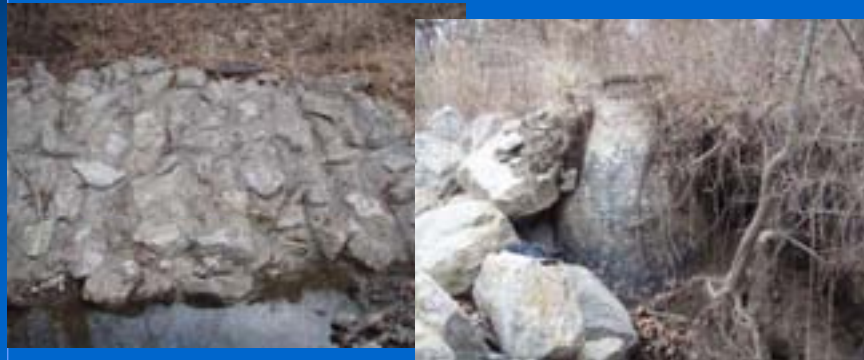
Manhole Armoring

- JCW was on a reactive basis to stream crossing repairs.
- JCW then began inspecting crossings themselves and could not keep up.
- JCW found that many repairs were not lasting and armoring stream crossings may not be the best solution.

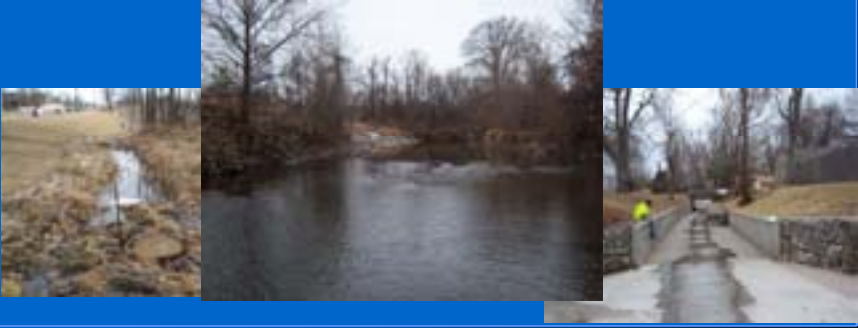
- We found that stream channels come in many forms and manholes can be located in odd places.
